LaSalle County Station, Unit 2
Facility Operating License No. NPF-18
NRC Docket No. 50-374

Subject: Licensee Event Report

FACILITY NAME (1): LaSalle County Station, Unit 2

TITLE (4) Scram on Low Reactor Water Level Due to Loss of 2A Turbine Driven Reactor Feed Pump Flow

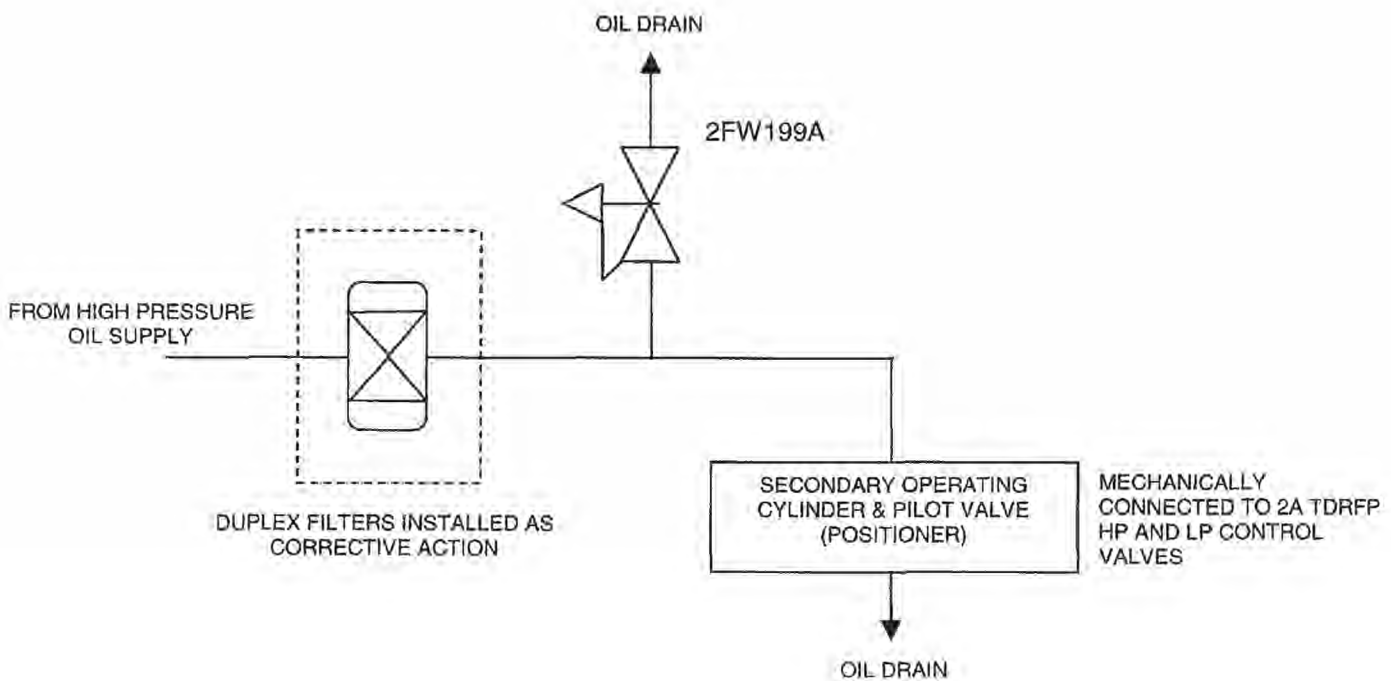
Figure 1

The root cause of the event was the intrusion of wear products into the high pressure control oil pressure regulating relief valve (2FW199A) that were in excess of the valve's tolerances. The wear products became lodged between the valve seat and disk, allowing the high pressure control oil supply to drain. With an inadequate oil supply to the secondary operating cylinder of the 2A TDRFP control valve, the valve closed, resulting in the 2A TDRFP ramping down in speed (see Figure 1).

The corrective action was to install in-line duplex filters on the 2A and 2B TDRFP high pressure control oil system supply lines. Filters for the high pressure control oil had been previously installed on Unit 1, but had not been installed on Unit 2.
